**SPILLWAY TESTS CONFIRM
MODEL-PROTOTYPE CONFORMANCE**

By A. J. Peterka

Engineering Monograph

No. 16

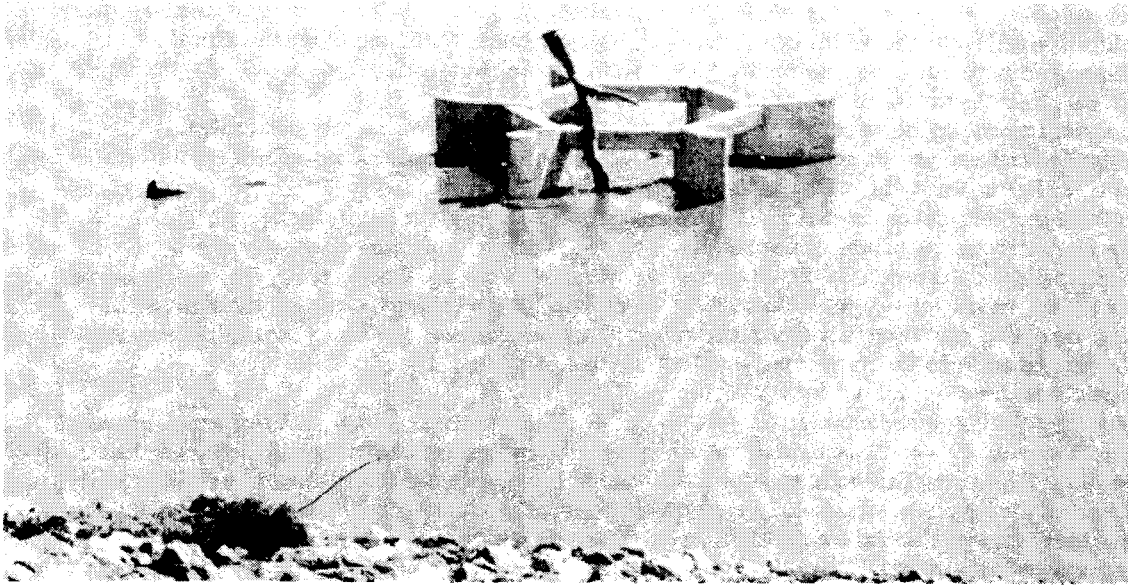
FIGURE 50--At headwater elevation 2283.6, vortex action was sporadic, with surface waves a few inches high sufficient to stop the action.

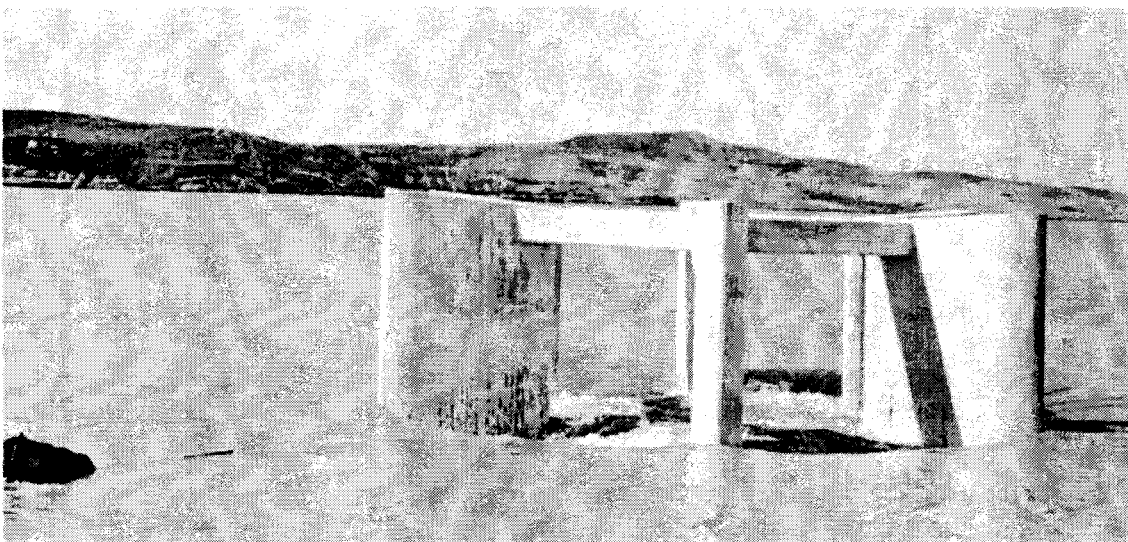
FIGURE 51--No vortex was observed when the water surface in the shaft was below reservoir level. Elevation here was 2277.8, about 1 foot above submergence.

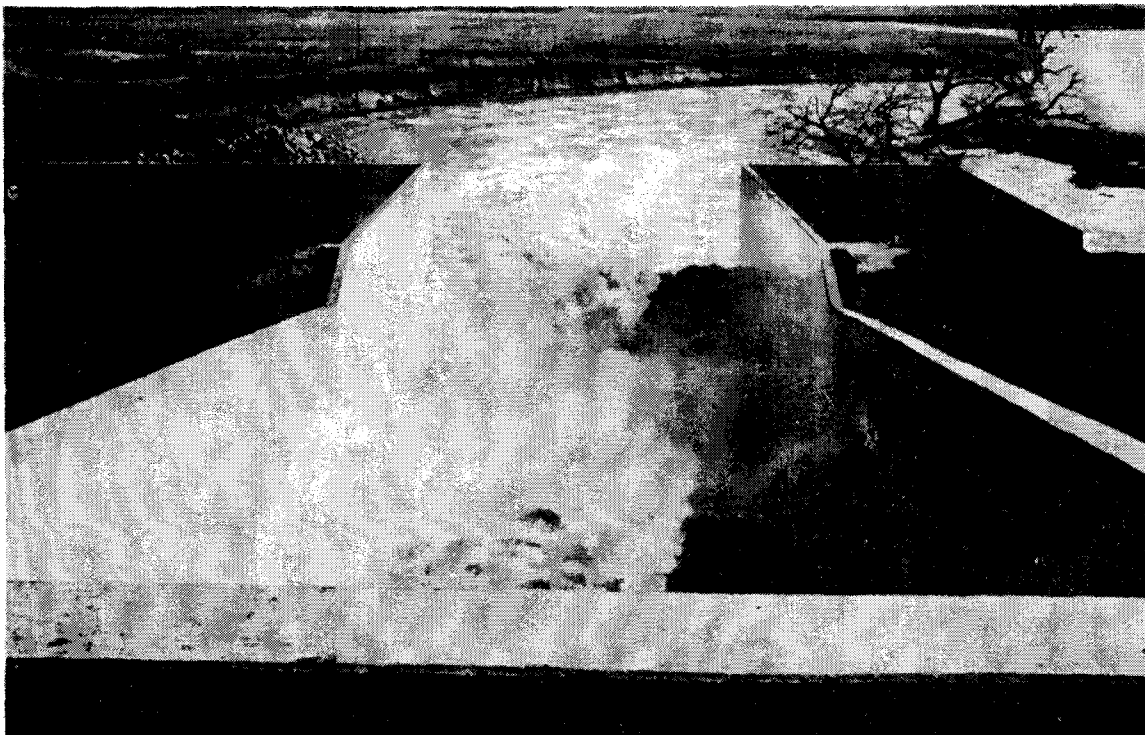
water. When there was no wind the spray fell back into the basin; at other times the spray was carried to areas adjacent to the basin. Under the worst conditions, the backfill along the basin training walls, downstream from the toe of the jump, became muddy and difficult to walk on. However, no washing of the backfill or other damage was evident, see figure 57B.

B--Stilling basin performance showing turbulence at the toe of the hydraulic jump and fins along walls of the transition. Spray from the jump caused wet areas adjacent to the walls.

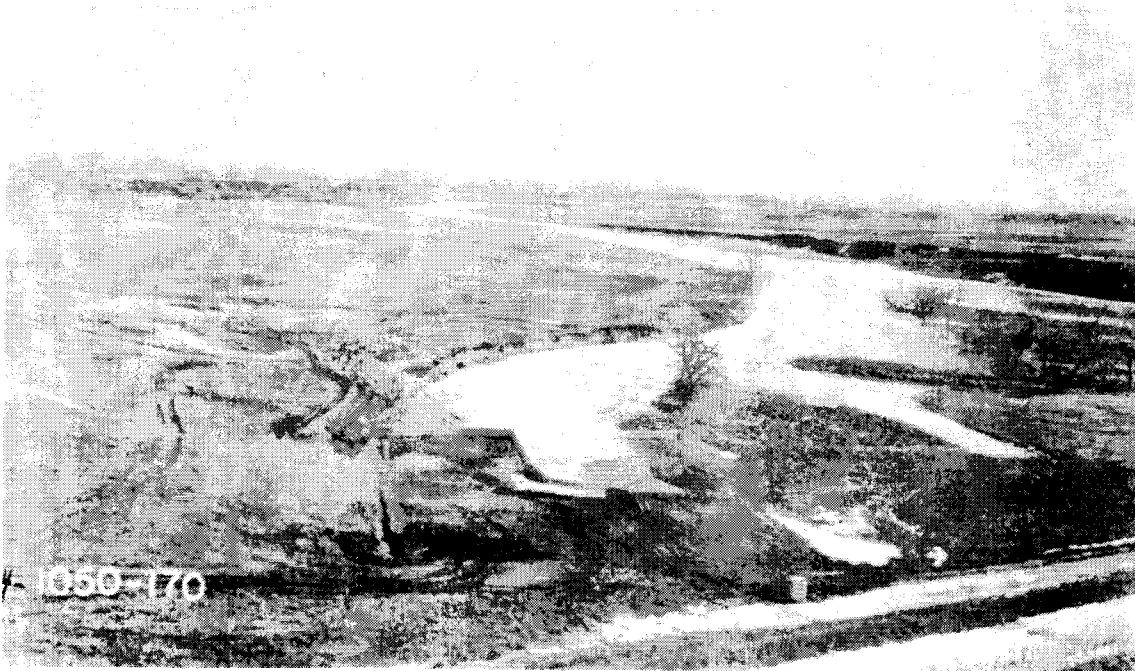
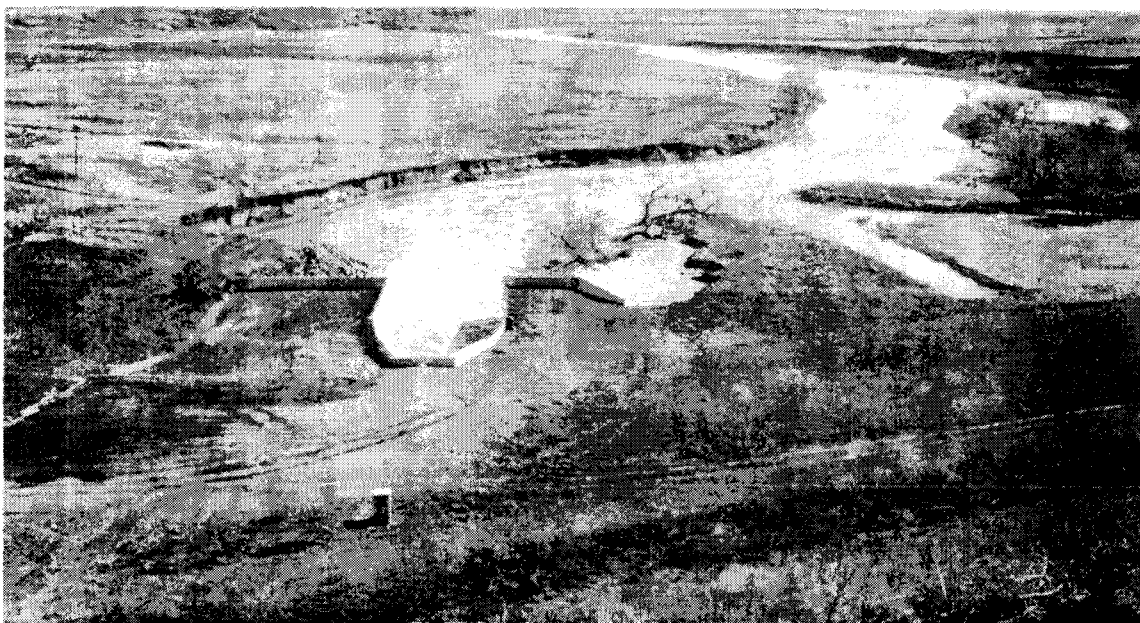
FIGURE 61--Channel erosion caused by 1952 flood at Shadehill Dam.

During operation the riprap on the right bank was soon submerged and the waves began to erode the soft earth. The trees were undermined and a new channel cut to the right of the trees (figures 58 and 62B). The surface velocity and waves attacked the left bank just downstream from the end of the riprap, causing rapid decay of the soft material for several hundred feet downstream. A sizable area was eroded at the end of the riprap, causing an eddy to form in the area. This action became progressively more violent and the eroded area enlarged until the riprap was attacked from behind. The effectiveness of some of the riprap was lost, since it slumped into a low pile, see figure 62A. It was estimated that the left bank line downstream from the riprap had receded as much as 80 feet as a result of the combined velocity, wave, and eddy action. The waves that were partly responsible for the left bank damage were similar to those shown in figure 58.

Before Flood
Downstream area before significant bank damage had occurred.

The bank damage in itself was considered inconsequential in that the land in the immediate area was expendable. However, the bank damage caused concern because of the possibility of the tail-water being further lowered and further aggravating operation of the stilling basin. The extent of erosion of the banks is evident in figure 60. To repair the bank damage, a band of riprap 50 feet long was placed across the channel bottom and up the channel banks. The right bank, figure 62B, was replaced to an elevation higher than the original and riprapped to prevent widening of the channel. Riprap was also placed along the left bank beyond the proposed 50-foot

extension and in other locations where it appeared that the existing riprap needed reinforcing. These repairs should prevent further lowering of the tail-water during future floods.
